SAFETY ALERT

Contractor Medical Treatment Incident - Germany 1/10/09

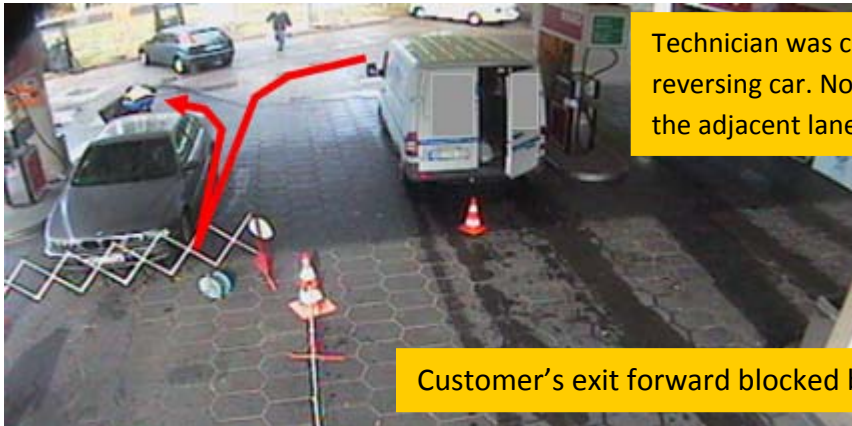
Technician was crouched down with his back to reversing car. No barrier. Own service van blocking the adjacent lane

Customer's exit forward blocked by other contractor's barrier

- The individual **was trained** on the ExxonMobil barricading principles and **he had** the barricading **equipment** stored in his service van however he decided to completely **disrespect the barricading rules, ie, the Golden Safety rules** – it was only going to take one minute - so several shortcuts were taken
- Poor quality of any LMRA performed
 - One minute prior to the incident another car passed right next to the Technician who stayed without any reaction on that **call for caution**.
 - He did not wear a hard hat
 - Technician was in a crouched position, with his back to customers car
 - With all the noise on the forecourt he did not hear the car backing up
- In order to exchange a bottle of nitrogen, located inside the shop building, the Technician had parked his van close to the shop entrance, but opposite of the barricading of the second contractor, blocking both lanes

1. **Always** apply the barricading principles i.e, Respect the Golden Safety Rules

2. Continuously apply the LMRA process
