Incident Sharing

CONTRACTOR'S FALL IN COOLING TOWER TOWER ARRESTED BY FALL PROTECTION EQUIPMENT

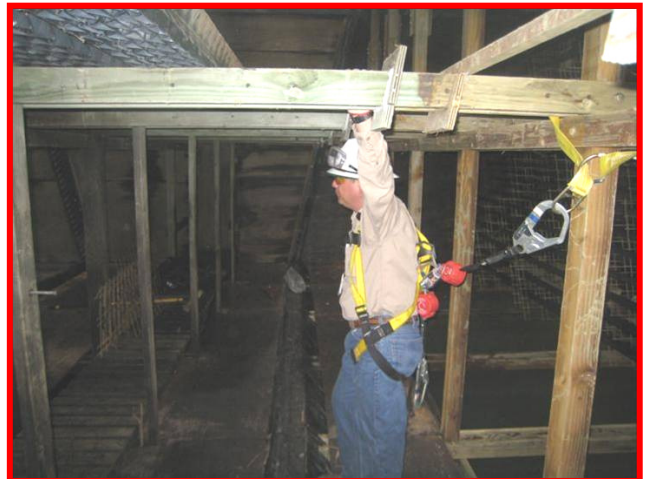
- At the time of the incident the worker was working on double 2x4 horizontal rafters that support the internals of the cooling tower. The worker stated that the 2x4 was slippery due to algae.
- The worker slipped from the 2x4's and fell toward the bottom of the cooling tower.
- The contractor was wearing the proper fall protection equipment – an SRL - since the clear space below the work area was less than 18.5 feet, and it saved him from serious injury.
- The worker was tied off to a proper anchor point, e.g. the intersection of the 4x4's and 2x4's (see photo).

- Evaluate all work platforms for hazards including wet, slick conditions. These hazards are to be immediately mitigated before allowing work to begin.
- Workers must be provided a suitable work platform of at least 18" in width while performing elevated work in all cooling towers. The platform material should consist of slip resistant material, e.g. metal scaffold planks.

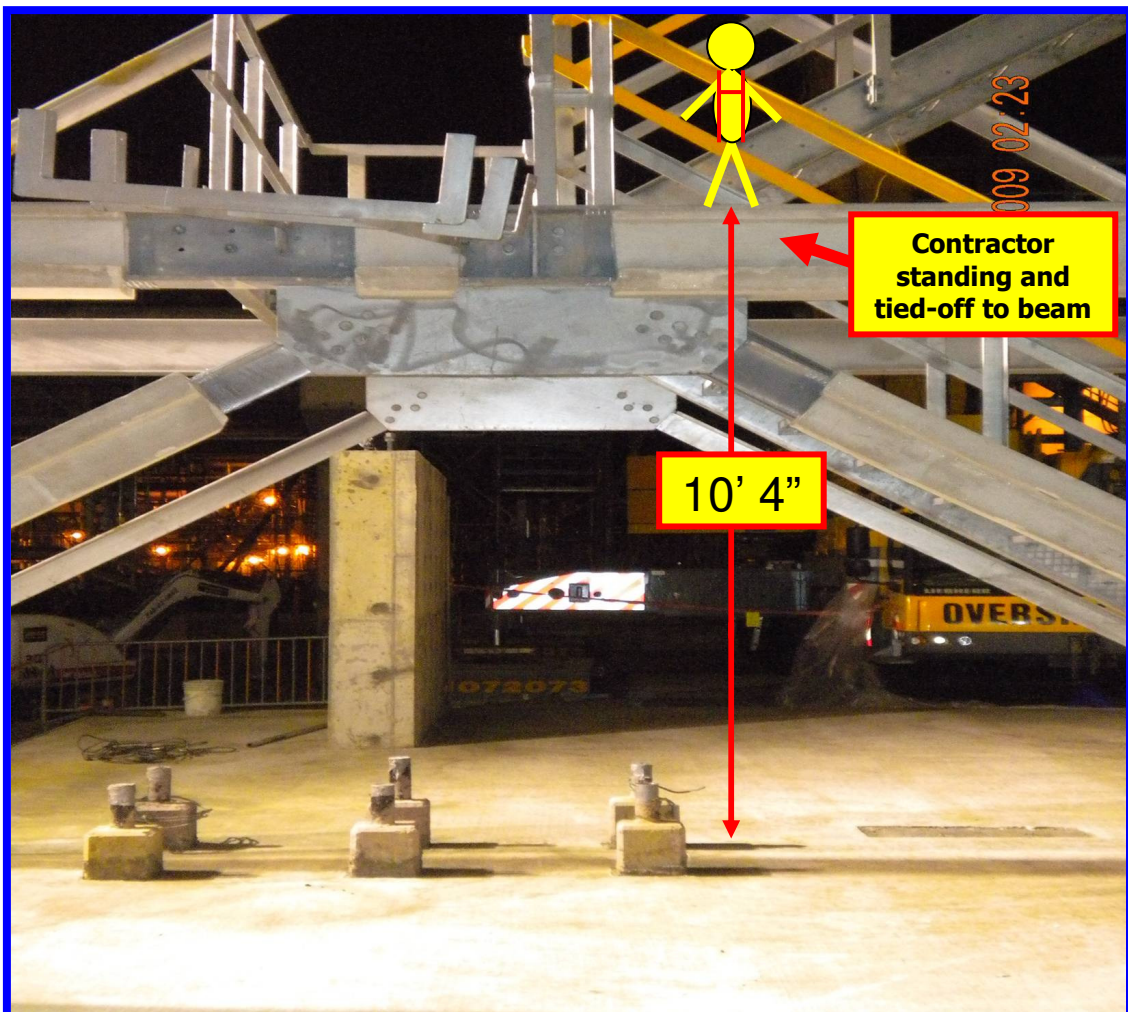
A contractor was working at an elevation of approximately 10 feet, 4 inches. In the process of relocating, the contractor fell. The contractor was “caught” by his fall arrest system and was uninjured. The contractor was utilizing the appropriate PPE – an SRL – and was tied off to an appropriate anchor point (I-beam).
