London Underground HEALTH, SAFETY & ENVIRONMENTAL ALERT

Issued by SQE
Ref. No. MSA 014/09

Miller Safety Harness

Volvo Compact Excavator Dipper Arm Failure

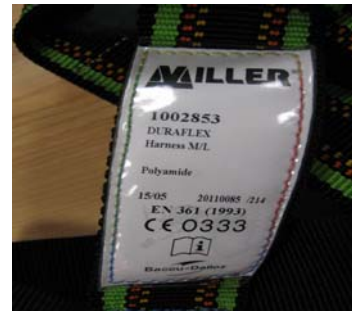
Fig 3 – This is the manufacturer's information label – note the serial number

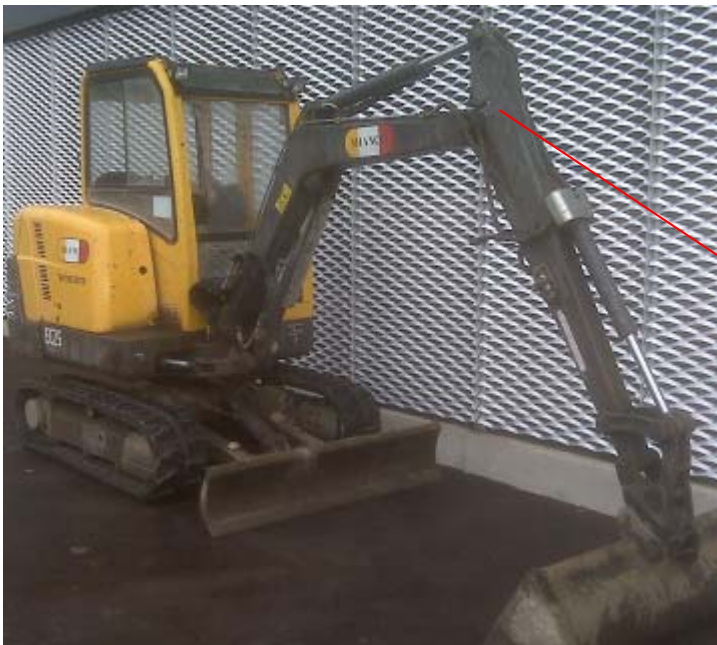
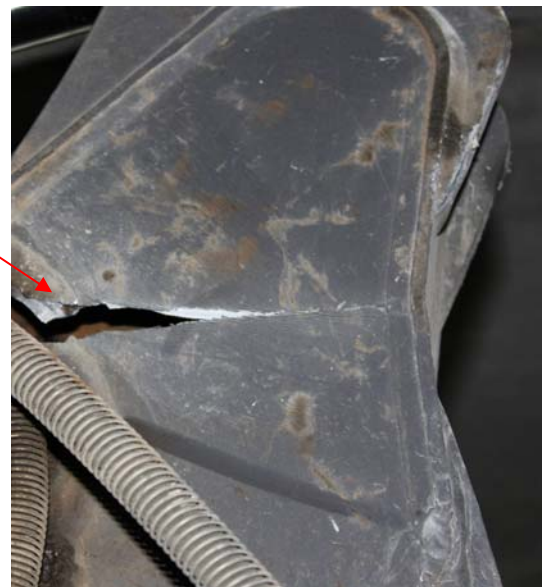
On the 5th October 2009 a Volvo EC25 compact excavator suffered a dipper arm failure whilst in operation on a worksite loading dumpers with spoil.

The pictures above show the failed dipper arm. The failure has been identified as a manufacturing fault with the dipper arm welding.

Models affected: EC15BXR, EC15BXT, EC15BXT, EC20BXT, EC20BXTV, EC25

Confirmation from the machine supplier that the machine has been checked as per the Volvo Service Bulletin No 42K version 1 (attached) prior to use.
