SAFETY ALERT

14/10/2009 AM Construction Restricted Work Incident – Italy

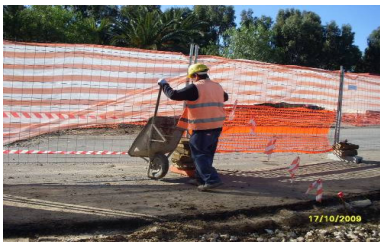
1: Employee putting the wheelbarrow in a vertical position

The soil at the location contains clay. The heavy rains during the days prior to the incident had made the surface wet and slippery. In addition, the clay also stuck on the sole of the safety shoe, compromising its grip. At the time of the incident the IP was standing on an area that was still covered with asphalt, and he assumed it was a safe walking area. During the rotating movement, the IP lost grip on his support leg making him lose his balance and fall forward on the asphalt.

- Make JSA job and site specific :
 - Although slippery site conditions were addressed during daily start work discussion, the fact that also regular walking zones could get compromised was not specifically addressed. As a result no work method was discussed or agreed to clean or change footwear when coming out of the slippery work area
- Continuously perform the LMRA process
 - LMRA process was interrupted when getting onto the “regular” walking zone

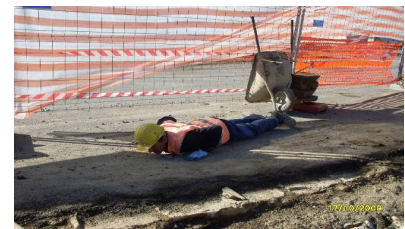
2: Victim turned 90°, started walking and slipped on the soil

3: Victim is on the ground
