## Design Safety Alert

### Ceiling Collapse – Lessons Learnt

Ref. No 10/01

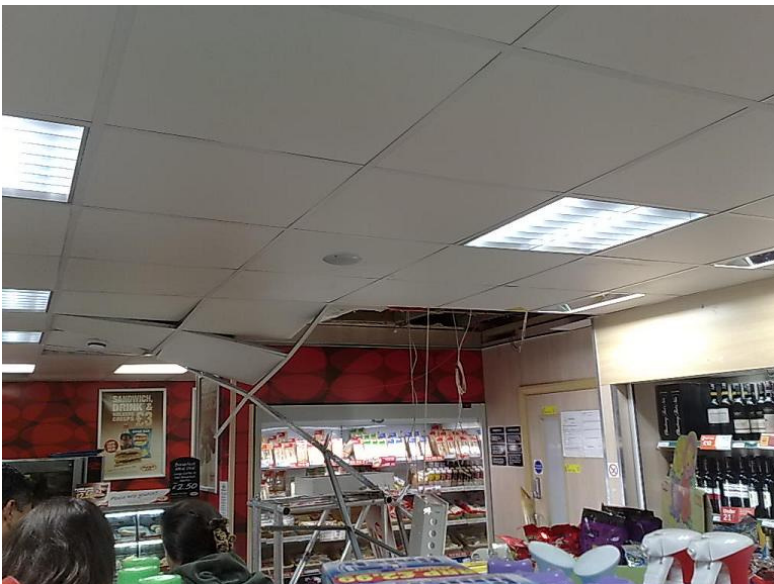
A partial ceiling collapse occurred whilst a maintenance contractor was carrying out routine lamp changing.

- **Suspended ceilings to be installed in accordance with manufacturers recommendations.**
- **Additional hangers to be attached to corners of cut-out for light fittings.**
- **Safety wires/chains to be fitted to light fittings where appropriate.**
- **Installing contractor – if evidence of insufficient fixing structure, consult with the Project Manager.**

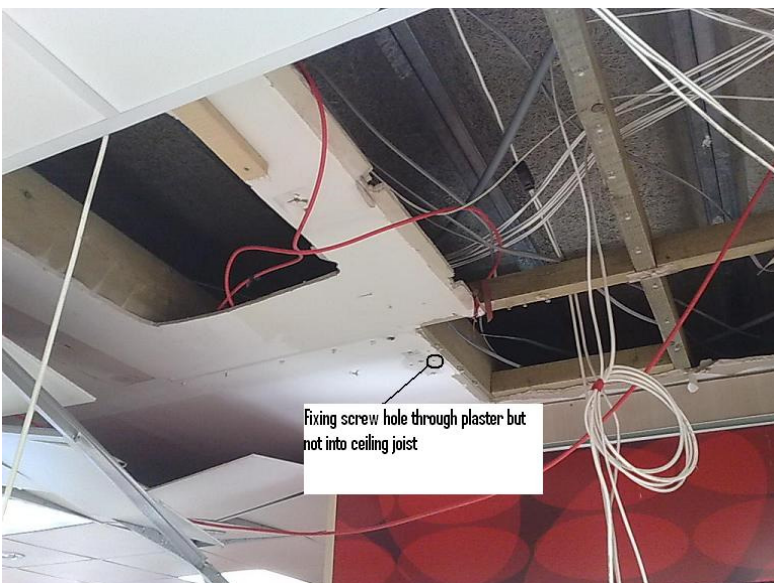
The root cause of the collapse was discovered to be an inadequate fixing of the suspended ceiling hanger.

The fixing concerned missed the target joist and was only made into the adjacent plasterboard.
