Safety Alert - March 09 BNL Medical Treatment Incident – Cut in Fore-Arm

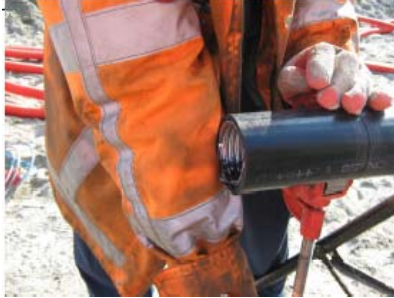
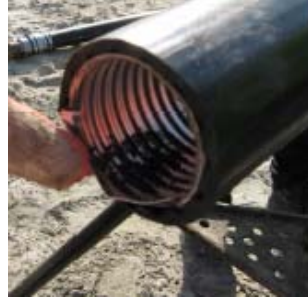
When cutting a section of a 2" Flexwell Secon-X piping, a worker grazed with his right arm against the sharp and unprotected end of the pipe. A burr perforated his sweater and cut in his fore-arm. The resulting injury required 6 stitches.

Improper work method followed

- End of pipe not cut according manufactures instructions
 - o An angle grinder was used which left burrs
 - o A clean cut needs to be made by cutting off 1 cm of pipe with a hand saw
 - o End of pipe not protected with a cap or tape

Design and tools - Use of the proper tool to cut the piping and the use of a protective cap

- A JSA should have been developed, based on Supplier's working instructions, which should cover all steps of the process, including the appropriate body protection
- The instruction itself should have taken place Earlier in time with worker's full understanding ensured
